Maryland Historical Trust
State Historic Sites Inventory Form
Maryland Inventory of Historic Properties

Survey No. WA-I-844

Historic Name 13052 Clopper Road

City, Town Vicinity of Leitersburg

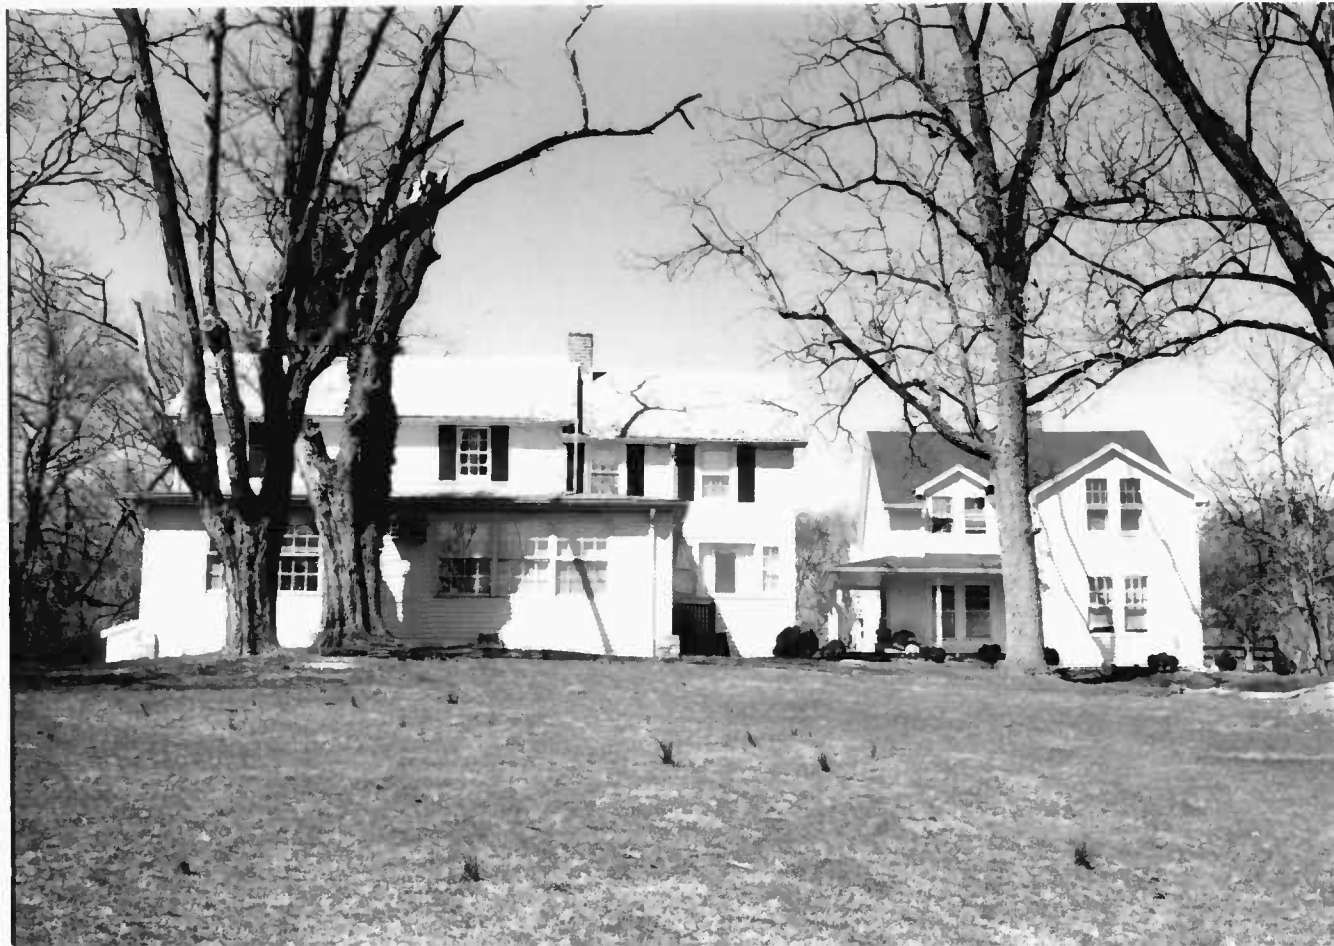
1 of 18

East facade of farmhouse and newer house

All three sections of the building are visible on the main (east) facade. However, the original prominence of the main house block and entrance is substantially altered by the projecting three-quarter facade porch addition, which is now enclosed and holds the primary (side) entrance to the house. The porch, clad in aluminum siding, extends across the entire front of the original building and partially obscures the addition as well. Originally open, the porch is now fully enclosed by the siding and by eight-over-eight double-hung windows, six of which are on the east facade. The porch has a shallow, hipped, standing-seam metal roof and no entrance on this facade. The vent of a built-in air-conditioning unit is visible near the eave. With the exception of low stone piers at the corners of the porch, the foundations are not visible along this facade, as the siding extends to the ground. Above the porch, two symmetrically placed windows of the original building are visible; these are six-over-six, double-hung sashes and have shutters. The addition, partially obscured on the first story by the porch, features a tripartite picture window on the first story and two six-over-six, double-hung replacement windows with shutters, placed more closely together than those of the original house, on the second story. Both the original building and the addition have standing-seam metal roofs with decorative snow guards at each seam; these take the shape of stylized trees on the original house and eagles on the addition.

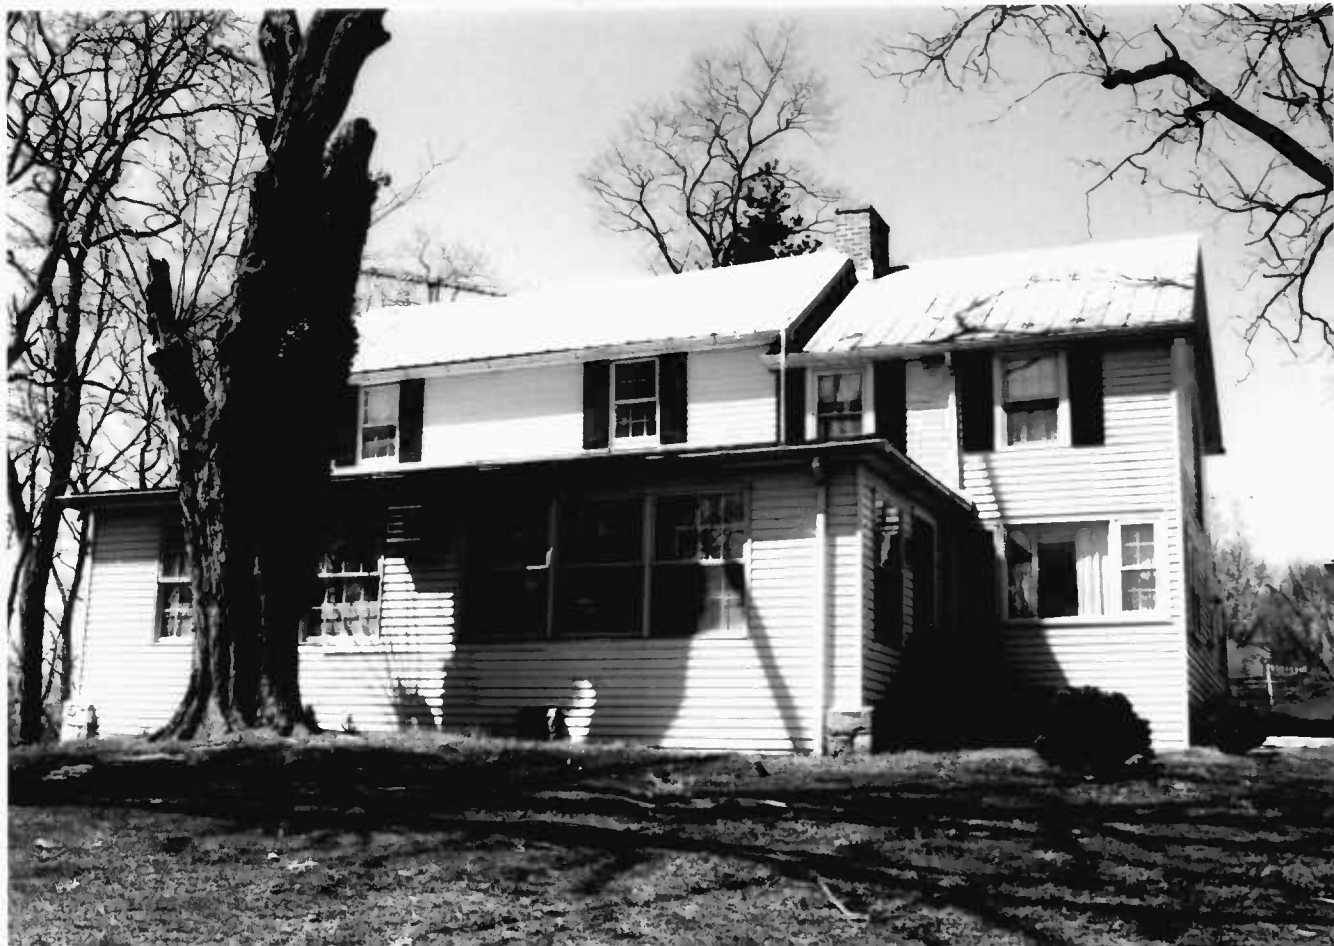
2 of 12

East side of Farmhouse

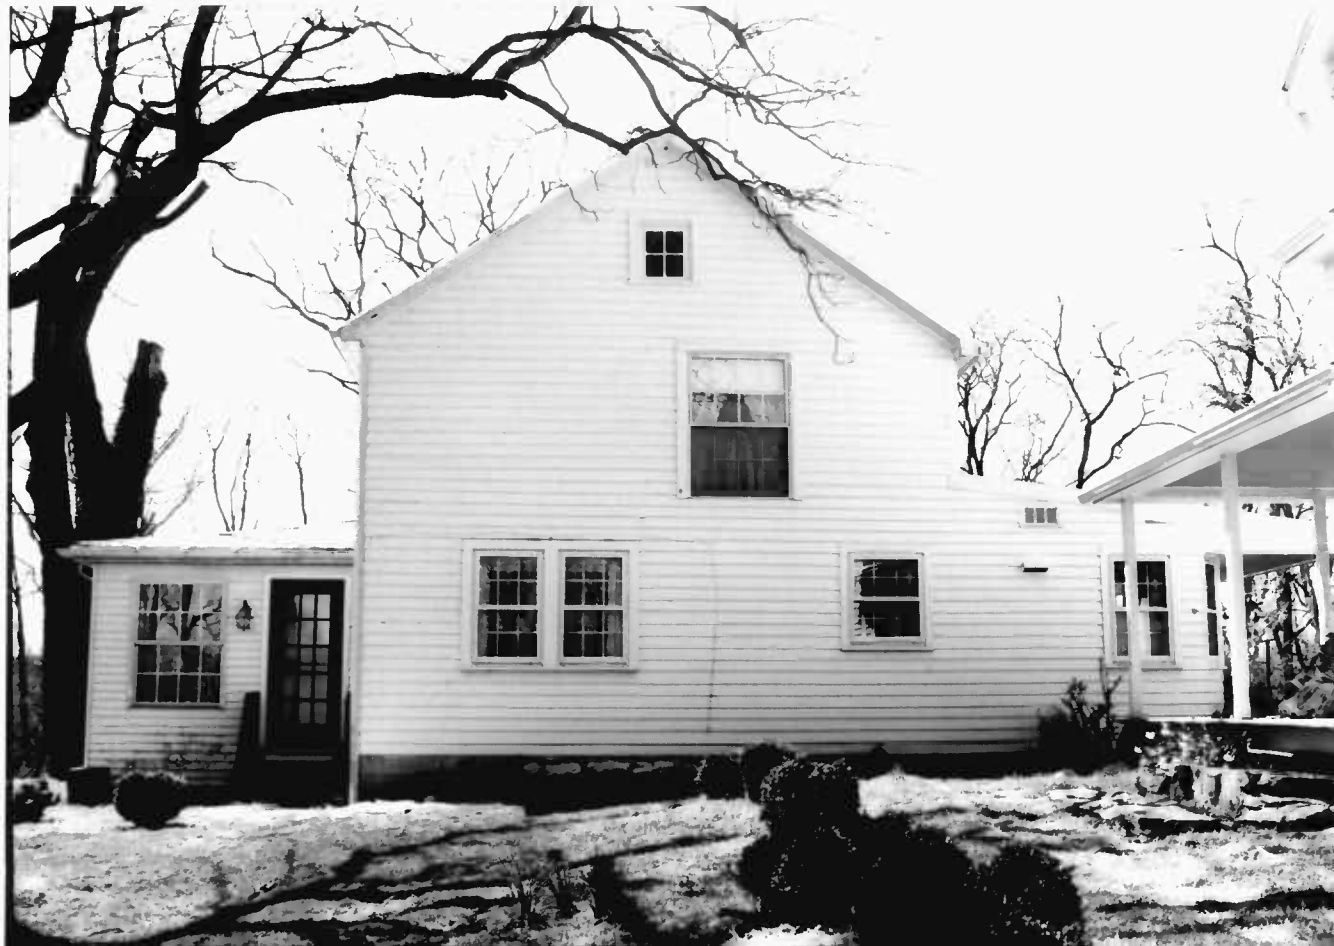
#3 of 13

North facade of farmhouse

One entrance to the house is on the north side of the porch, and is accessed from a stoop with two steps and a simple balustrade. To the left (east) of the door is an eight-over-eight double-hung porch window. The north facade of the addition projects several feet north of the porch entrance, and is characterized by a variety of window openings. On the first story are three asymmetrically arranged openings; from left (east) to right these are a pair of six-over-six sash windows, a six-over-six sash window that is wider and shorter than either of the paired windows, and a single six-over-six sash window. The single window on the second story is an eight-over-eight sash window similar to those on the porch; this window, which is larger than the others on the main house block or the addition, was added by the Baldoffs, probably in the late 1960s, when they discovered that their furniture did not fit up the house's narrow staircase.⁷ A small four-paned window near the peak of the gable lights the attic. The foundation of the porch is not visible, but a portion of the foundation of the addition can be seen near the northeast corner. Right at the corner, a section of the foundation is constructed of concrete block; just to the right (west) of this, the foundation is made of fieldstone.

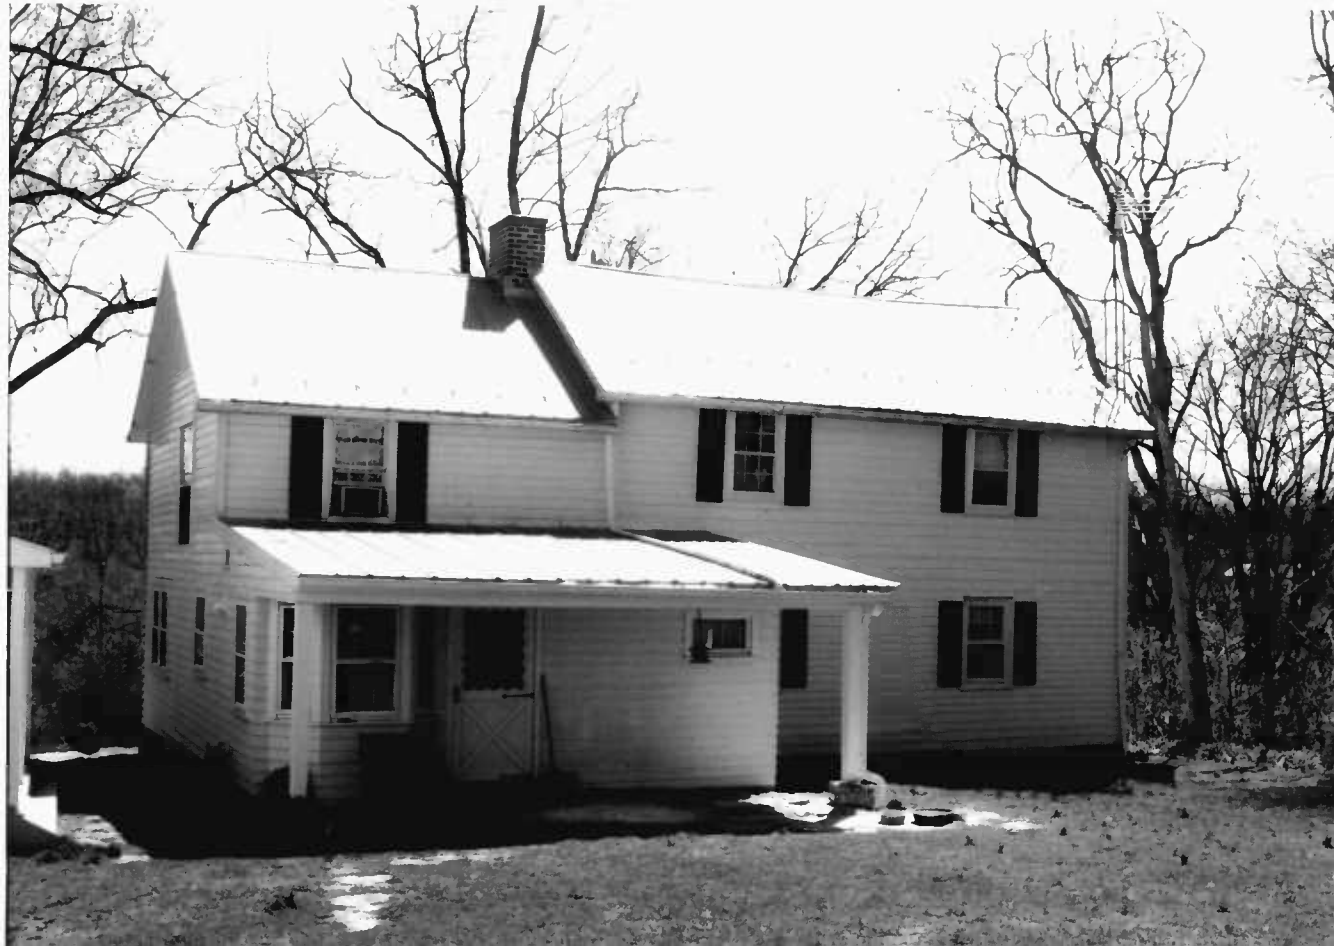
#4 of 13

West facade of farmhouse

The main house block and addition are clearly visible on the west facade, and a small shed-roof porch extends from the addition. The porch is supported by two plain, square posts, and a second entrance is

located under it. Part of the porch has been filled in by an expansion of the kitchen and bathroom, leaving a shallow open area shaded by the roof. The porch, which is several feet wider than the addition, extends several feet south of the intersection of the original house and the addition, obscuring a portion of the original building. To the north (left) of the back door is a bay window, and to the right is a small bathroom window. There are two six-over-six sash windows on the first story of the main house block, and two on the second story. The addition has one similar window on the second story. The variation in the size of the clapboards on the original building is easily visible on this facade, as is the original fieldstone foundation.

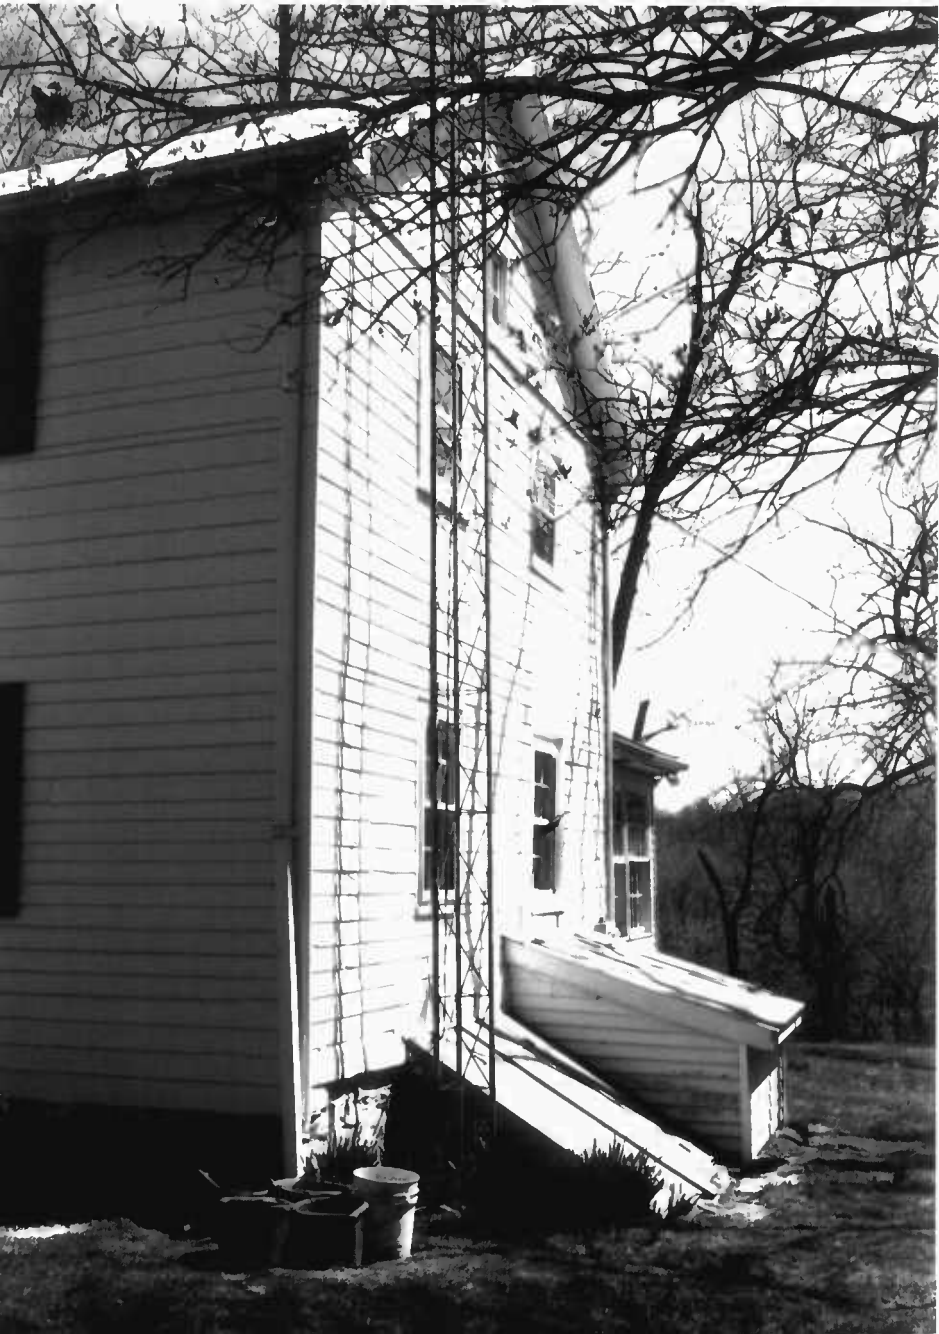
5 of 13

South facade of Ambrose

The south facade of the main house block is quite regular, and projects a few inches from the south facade of the porch. Portions of the fieldstone foundation of the original house are visible near the corners of the building. Near the southwest corner of the building is a pair of outward-swinging cellar doors set on a shallow angle low to the ground. To the east (right) of the cellar doors is a small, low shed-roofed projection with no openings. Two six-over-six windows are symmetrically placed on the first floor, and two directly above them on the second floor. These windows do not have shutters. A four-paned window is located near the peak of the gable. The south facade of the porch features an off-center pair of eight-over-eight sash windows.

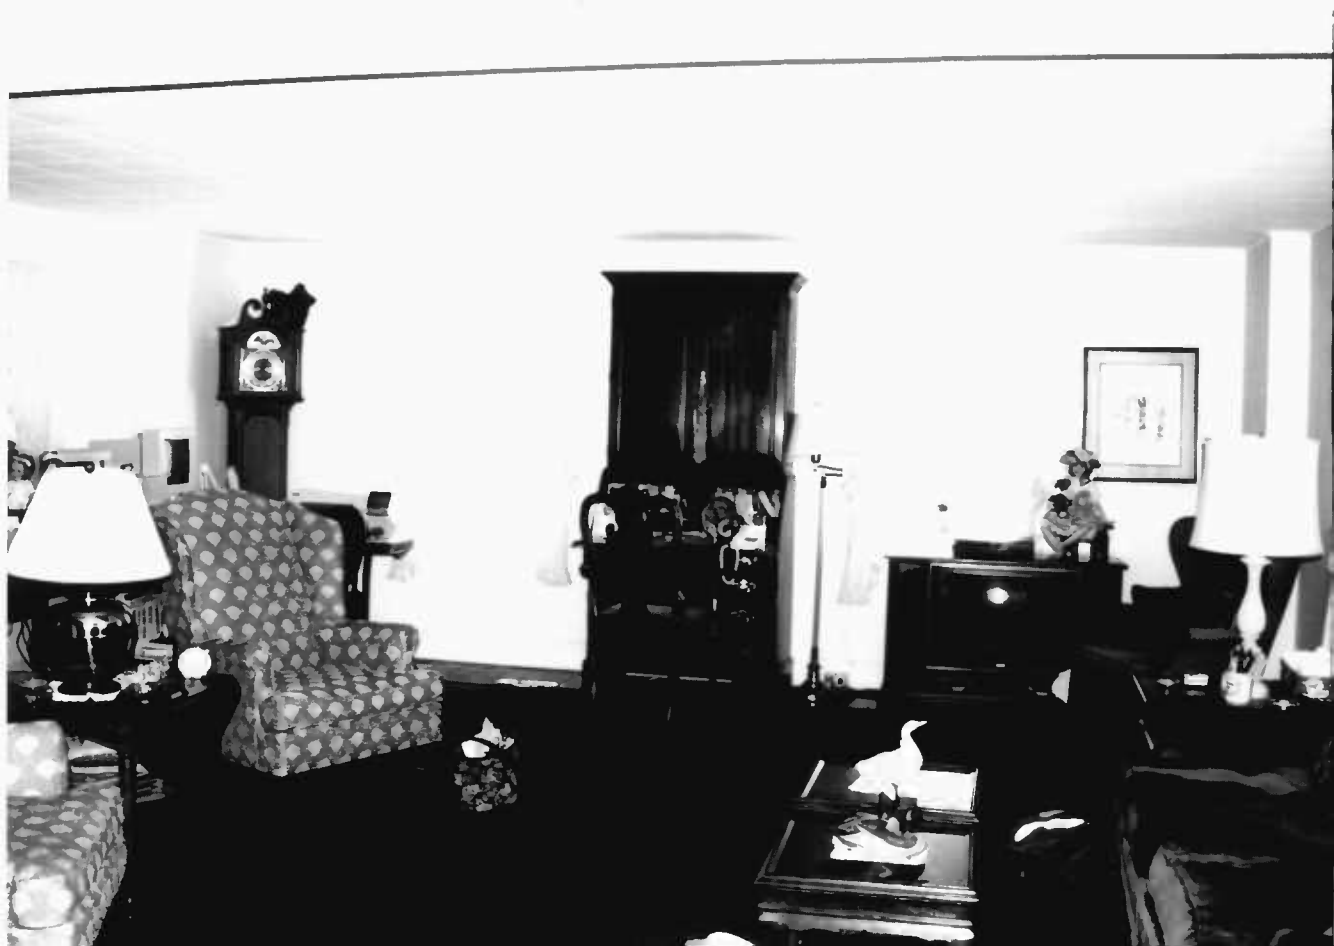
#6 of 13

Interior of living room, facing south

Little early or original material remains on the interior of the building. The first floor consists of three rooms, each relating to a different phase of construction: the living room (the original building), the kitchen (the addition), and the sun room (the porch, now enclosed). The large, rectangular living room comprises the entire first story of the original house. A doorway on the east wall, probably the original location of the front door, leads to the porch, and a doorway on the north wall leads to the kitchen. The living room features early or original pine flooring, laid in wide, irregular strips, and a steep, narrow quarter-flight stair in the northeast corner that may be original to the building. In addition to four exterior windows, two along the south wall and two along the west, a former exterior window now opens onto the porch. No early or original trim, finishes, or moldings are present. Marks in the floorboards indicate that the room was at one time divided into two or more rooms. A stone fireplace along the north wall does not appear to be original. Mrs. Baldoff believes that the low acoustical tile ceiling, and a steel beam covered in tile that bisects it, were installed by the Kauffmans, who owned the property from 1947 to 1967.⁸

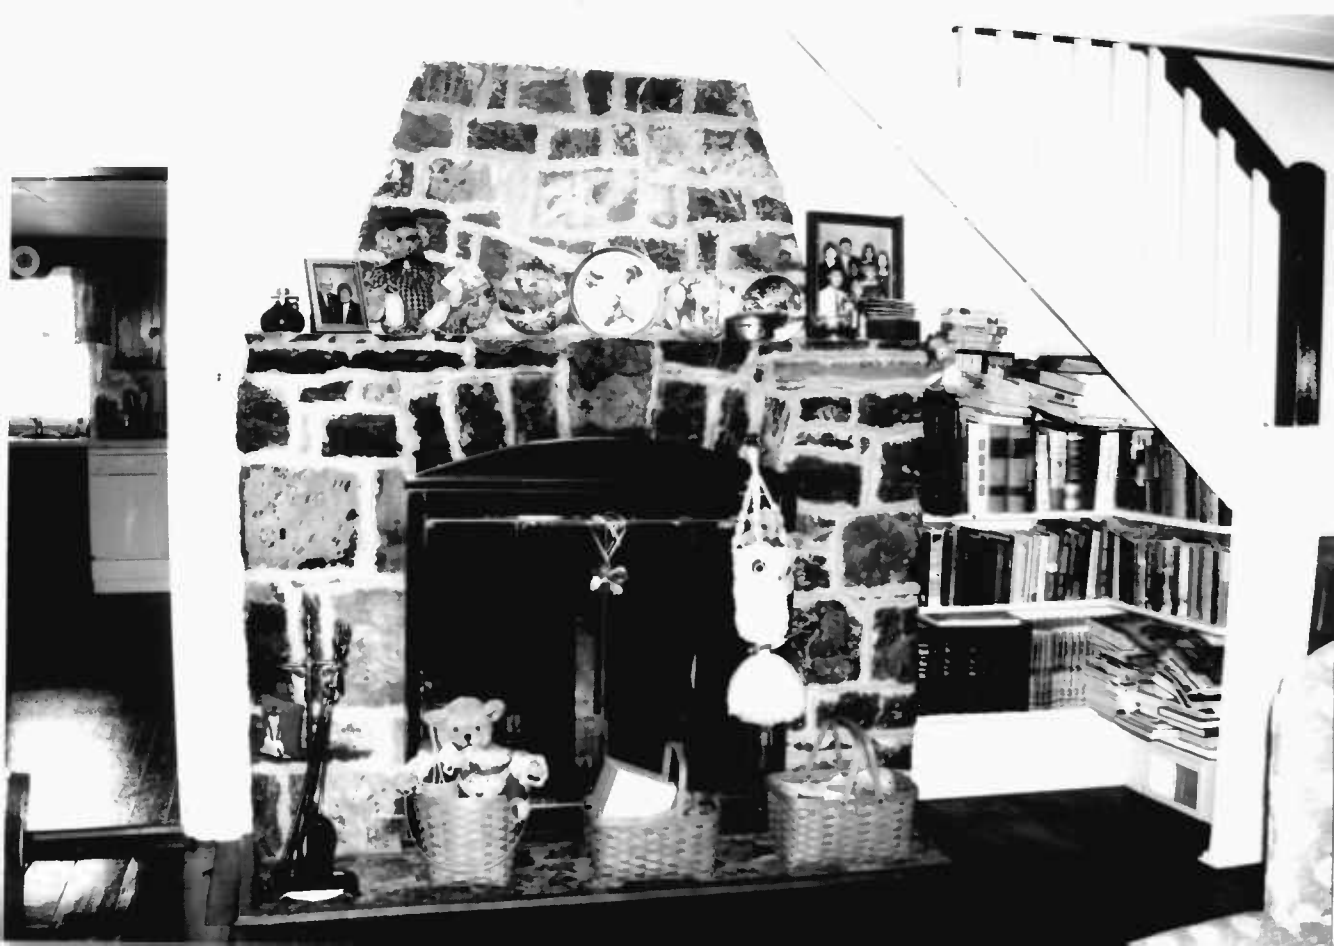
#7 of 13

Living room fireplace

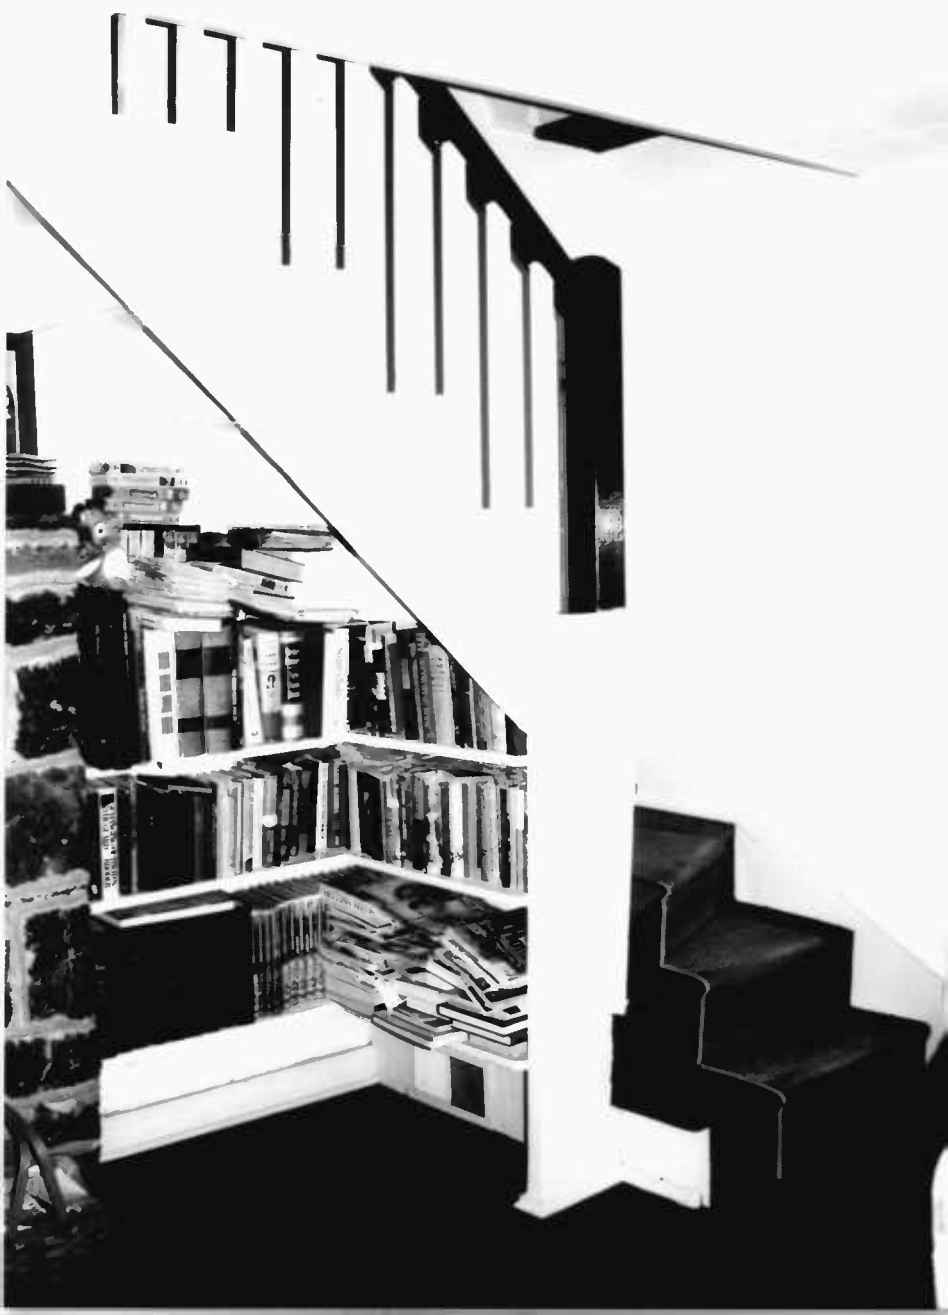
33-12

Living room, view of stair

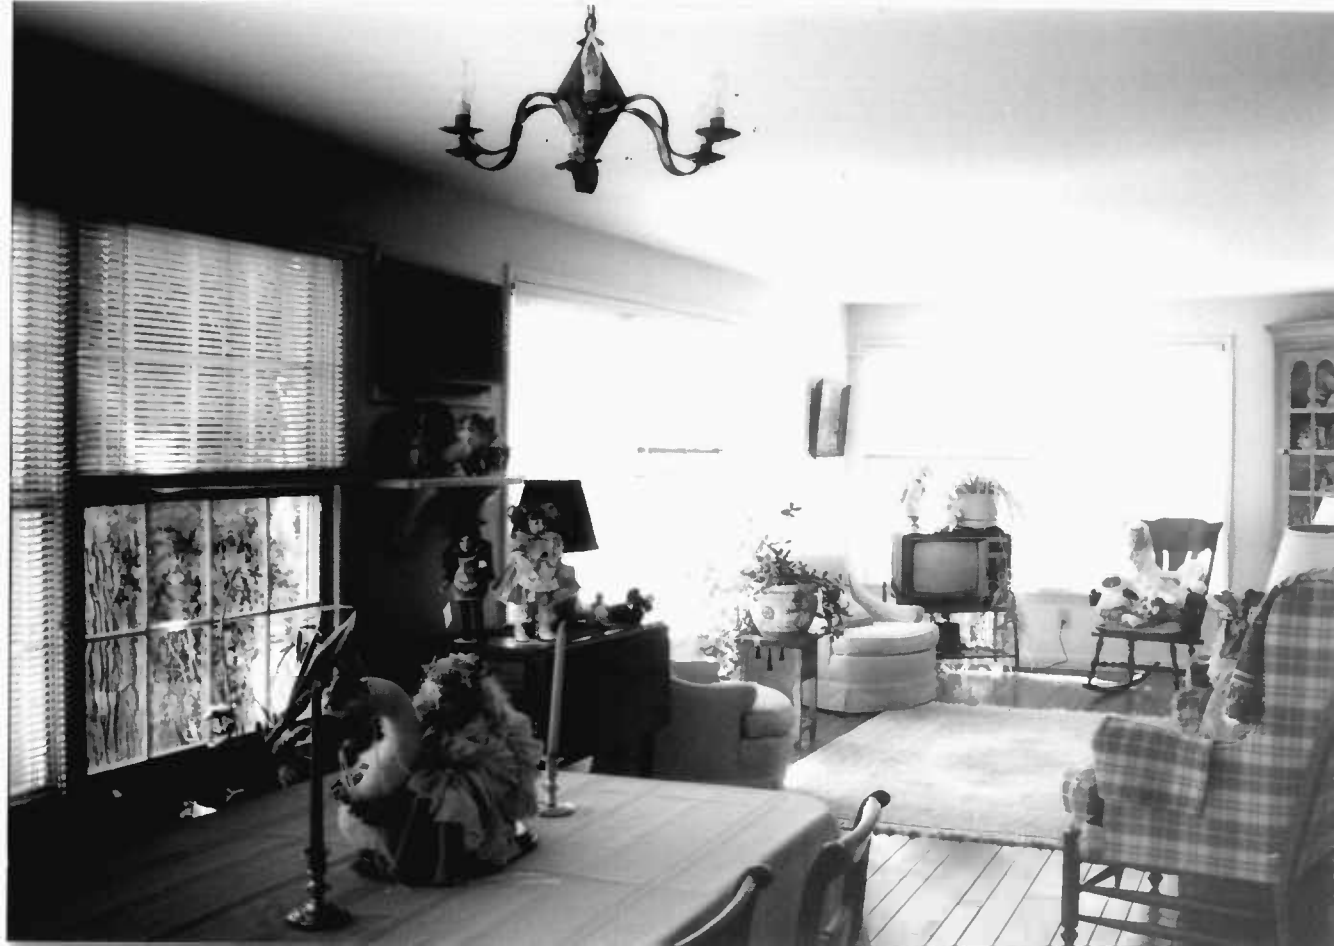
9 of 18

Porch, View Northwest

To the east of the original building is the porch, now enclosed. It has windows in the east and south walls and a window and exterior door on the north. Interior doors on the west wall lead to the kitchen and living room. A long, narrow room, the porch has a wood floor similar to, although more recent than, the wood floor of the living room. Mrs. Baldoff said she and her husband enclosed the porch, which was previously open, about fifteen years ago. At that time, they did not change the exterior dimensions of the porch, but dropped the floor by about six inches to create the effect of a higher ceiling. She said she believes the open porch may have been added by the previous residents, although she said a smaller porch may have been in place before that time.⁹

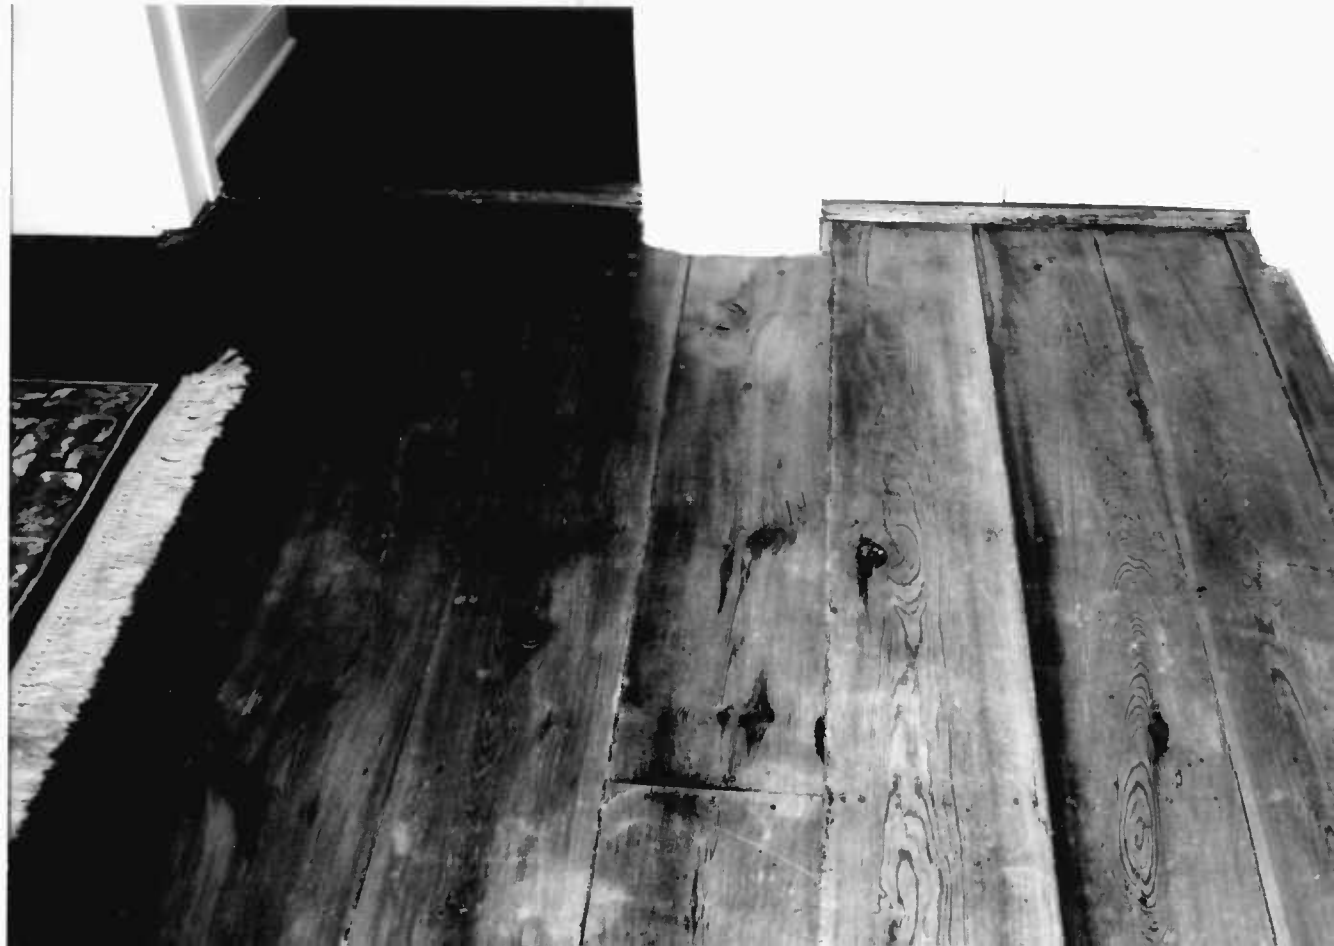
#10 of 13

Floor boards in second-floor hall

The second floor retains several early or original architectural features. The pine flooring in the original portion of the building matches that of the living room, and is in better condition than the first-floor floorboards. Many or all of the second-floor windows in the original section are very early, possibly original, as can be seen in the unevenness of the glass. Mrs. Baldoff said, however, that she and her husband replaced the second-floor windows in the addition section, so these windows were installed sometime after 1967.¹⁰ The doors in the original portion of the building may be early or original. They are simply constructed of vertical boards, and have early or original hardware. The doors of the addition are not as old as those of the original house, but are similar in style. A variety of types of trim are present, including a very flat, unornamented surround on the hall closet door, and slightly more decorative surrounds on the bedroom doorways. The bathroom fixtures date to the mid-twentieth century.

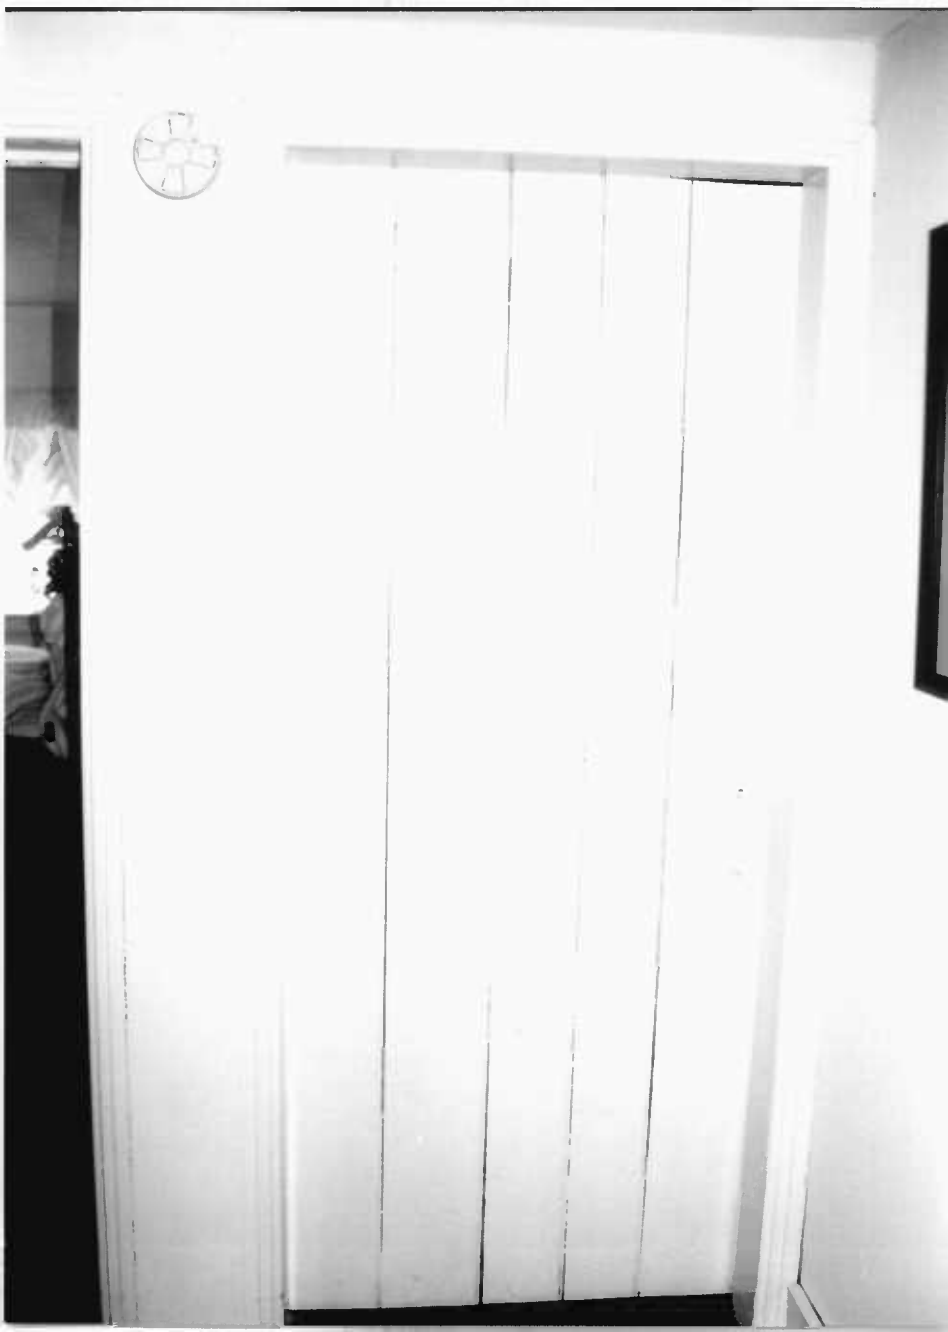
#11 of 19

Typical interior door, second floor

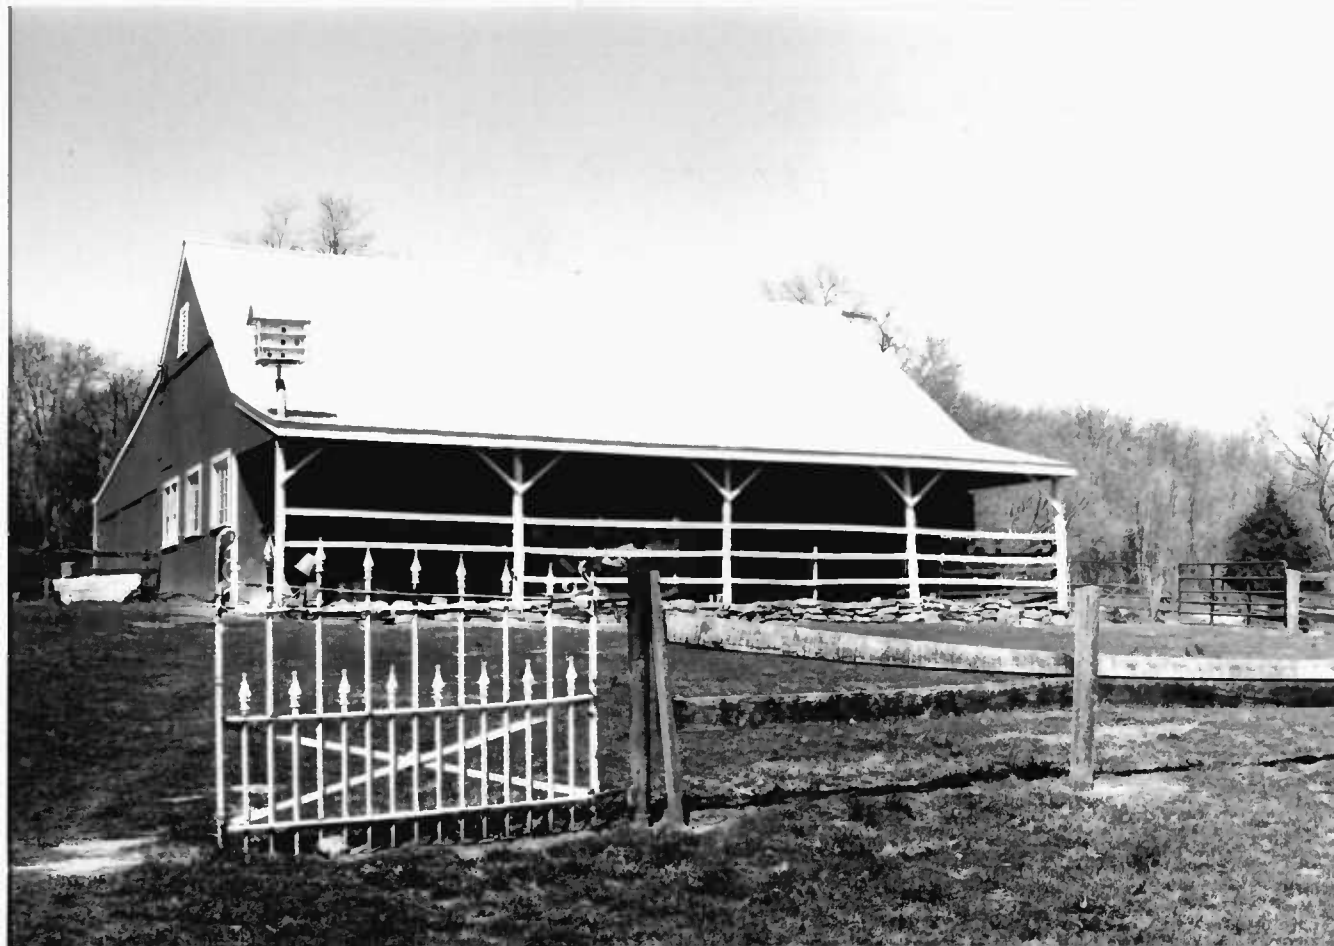
#13 of 18

East facade of barn

spring of excellent water and cistern at the door.”¹¹ Of these outbuildings, the only one remaining appears to be the barn located behind the house. The barn has a standing-seam metal broken-gable roof, with a long shed-roofed section attached to the west and a pent-roofed forebay to the east. Vertical board siding installed between about 1967 and 1985 covers the barn’s original cladding, which, according to Mrs. Baldoff, consists of vertical boards with spaces between them.¹² The siding extends to the ground, obscuring the barn’s foundations. The barn’s primary (east) facade is characterized by five roughly-finished wooden porch supports with angled braces. The foundation of the forebay is exposed, and consists of randomly laid fieldstone. Openings on the north facade include two shuttered sash windows, two rolling garage doors, and a vent near the peak of the gable. A hinged door provides direct access to the upper level. The south facade features two sixteen-paned fixed windows, a pair of windows, and another vent near the gable; hinged doors on the first level of the shed-roofed section and the second level of the gable-roofed section also open to the interior. The barn is currently used as a shelter for a horse and numerous fowl.

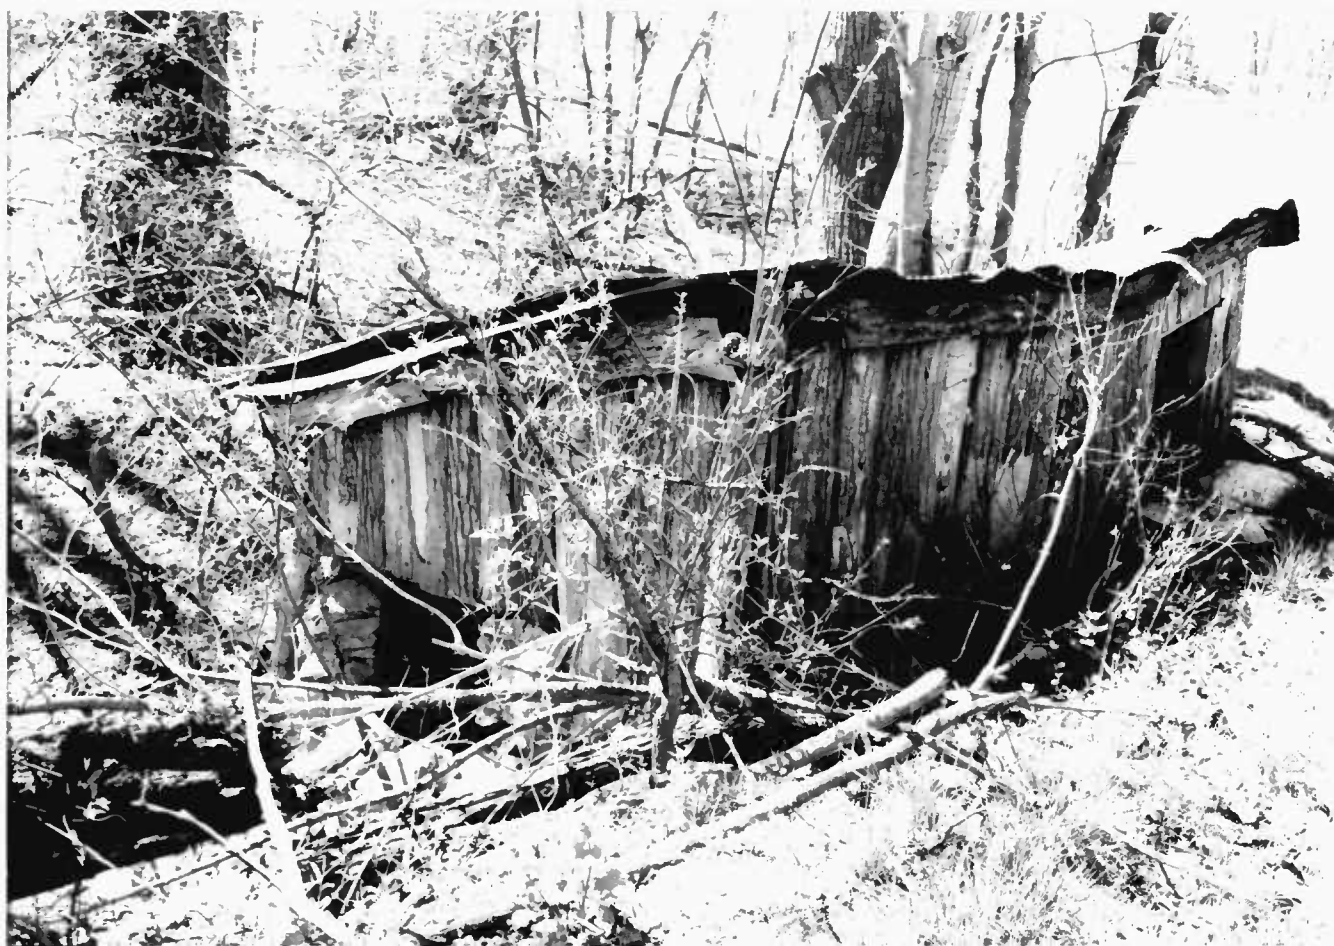
4 of 13

Springhouse

The other early structure on the site is a dilapidated springhouse, abutting a hillside along the north bank of the creek southeast of the house. Due to the condition of the structure and of the overgrown vegetation around it, it was not possible to gain access to the structure. The springhouse is near two springs. One of the springs is still active, while the other has gone dry in the past 30 years, which Mrs. Baldoff attributes to the rapid development of the surrounding area in recent years.¹³ The springhouse is a small structure, measuring approximately four by five feet, roughly constructed with a fieldstone foundation and log walls with a sloping corrugated-metal roof. It appears to have three openings, one near the roof on the west side, one near the eaves on the east side, and one near the ground on the north side.

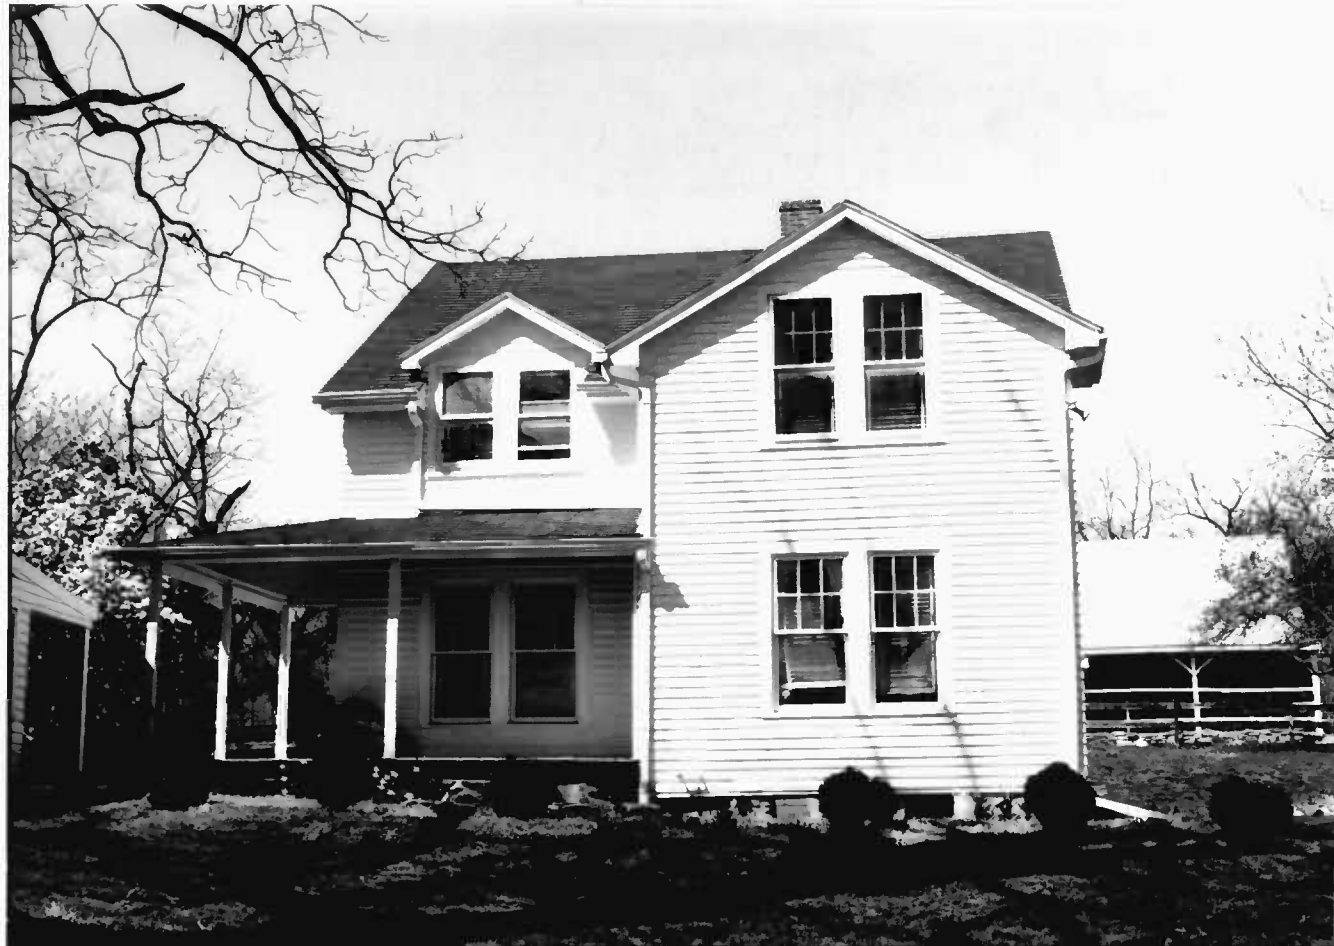
#15 of 19

East facade of newer house

A two-story frame house with clapboard siding and an asphalt-shingled roof stands a few feet north of the historic house. Mrs. Baldoff believes this was built by the previous owners, the Kauffmans, who owned the property from 1947 until 1967.¹⁴ Its primary facade, like that of the main house, faces east. The gabled roof is oriented north to south, echoing that of the main house, but unlike the main house, the newer structure has a low-pitched cross-gable and dormers on the east and west facades. A porch with very plain supports extends across half of the east facade and wraps partway around the south facade. The windows on the east facade are regularly arranged, paired six-over-one double-hung sashes, while the windows on the other facades are single six-over-one sashes. The building is currently used for storage.

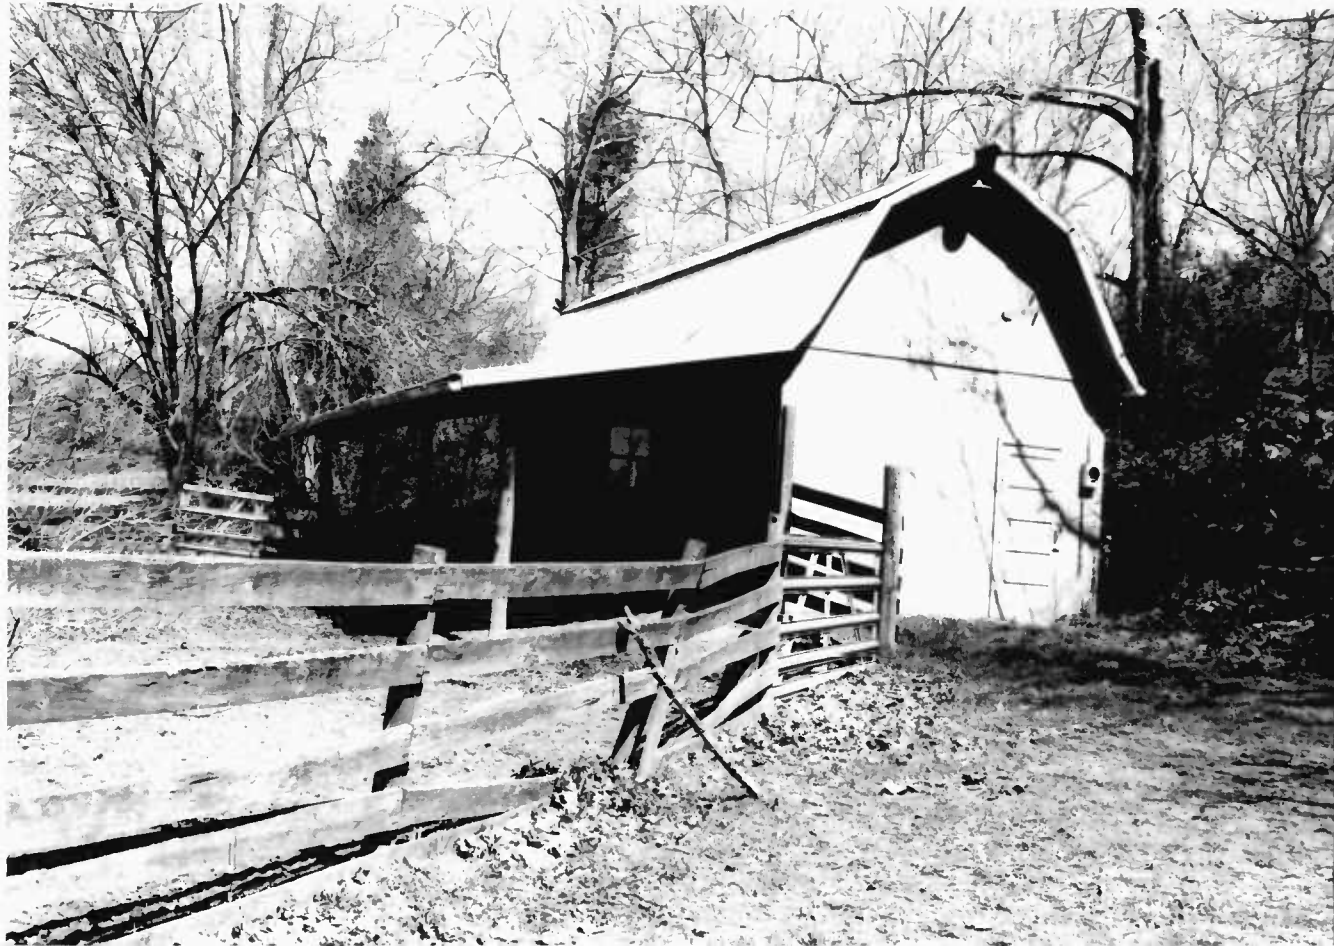
#16 of 19

Concrete-block shed

A small, concrete-block shed is situated along the northeast bank of the creek. Mrs. Baldoff said her husband built the shed about 20 years ago.¹⁵ The simply-constructed shed has a corrugated metal gambrel roof, and is completely open on the south side. A shed roof extends to the south to create an open forebay. A small area between the shed and the creek is enclosed with a rough plank fence. Mrs. Baldoff does not use the structure on a regular basis, as the low-lying land is muddy and occasionally floods. At the time of the April 1999 site visit, she was using the shed as a temporary shelter for a horse.
